Manhole Inspection Summary

Manhole # S11O__013MH

Location Address: **425 S Caton**

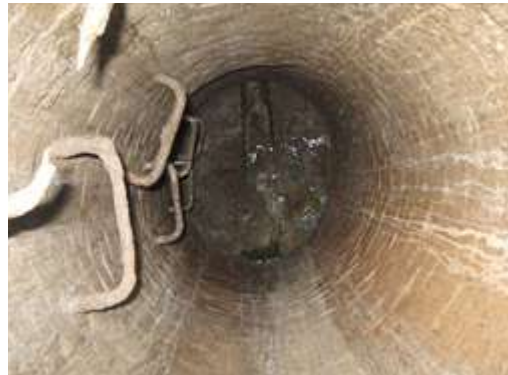
Top View

Heavy deposits on bench and in channel

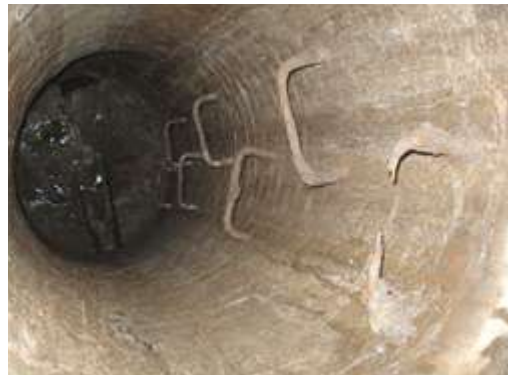
Defect 4

Infiltration: ☐ None ☐ Joint ☐ Cracks ☐ Mortar ☐ Roots ☒ **Wall**

Infiltration at chimney and Barrel

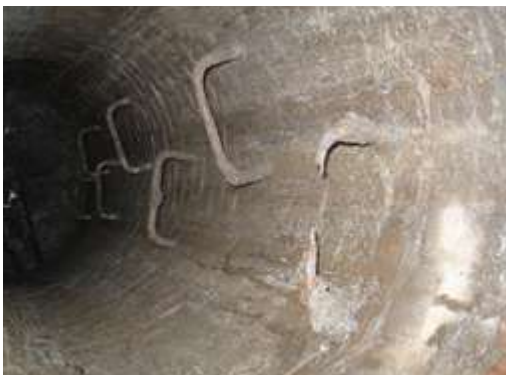
Defect 2

Infiltration: ☐ None ☐ Joint ☐ Cracks ☐ Mortar ☐ Roots ☒ **Wall**

Steps Count: **7** Missing: **0** ☒ **Corroded**

Corroded steps/Corbel infiltration

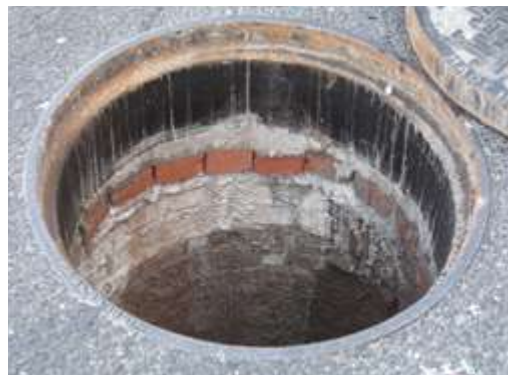
Defect 3

Condition: ☐ Sound ☐ Cracked ☐ Root Intrusion ☐ Loose Brick ☒ **Deteriorated**

Chimney Loose bricks and mortar under frame

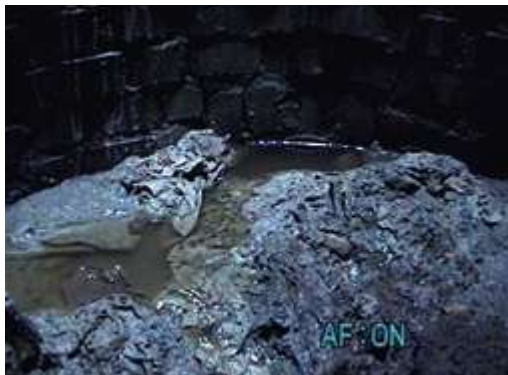
Defect 1

Condition: ☐ Sound ☐ Cracked ☐ Root Intrusion ☐ Deteriorated ☐ Leaks ☒ **Debris**

Heavy debris on bench
and in channel

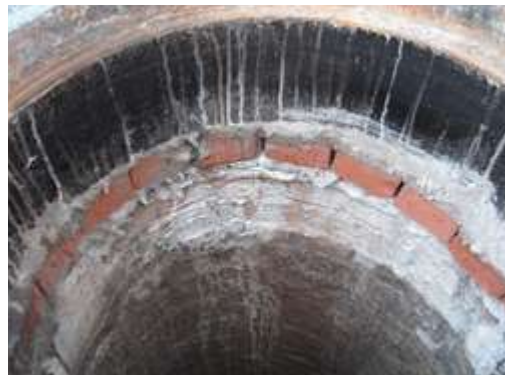
Defect 4

Infiltration at chimney and corbel

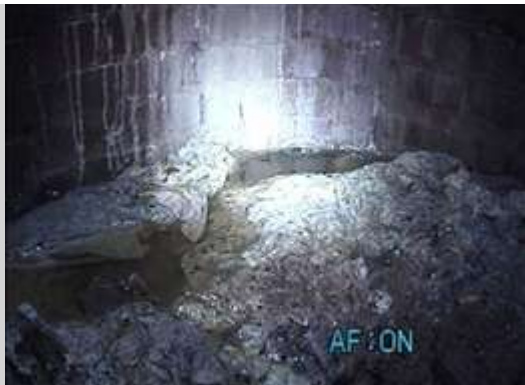
6 O'Clock Inflow

Heavy Debris on bench and
in channel

Pipe Height: **7.2** (in.) Rod and Bar (Angled)
Pipe Material: **Clay** ☐ Pipe Lined
Invert Depth: **13.20** (ft.) Flow Characteristics: **Slow**
Deposits: ☐ None ☐ Mud ☒ ~~Gravy~~ ☒ **Debris** ☐ Grease
Silt Depth: **8** (in.) Deposits Extent: **Heavy**
Infiltration: **None** Pipe Seal Cond: **Sound**
